# WHADDON FACT SHEET

## No.3 – ST MARY'S CHURCH

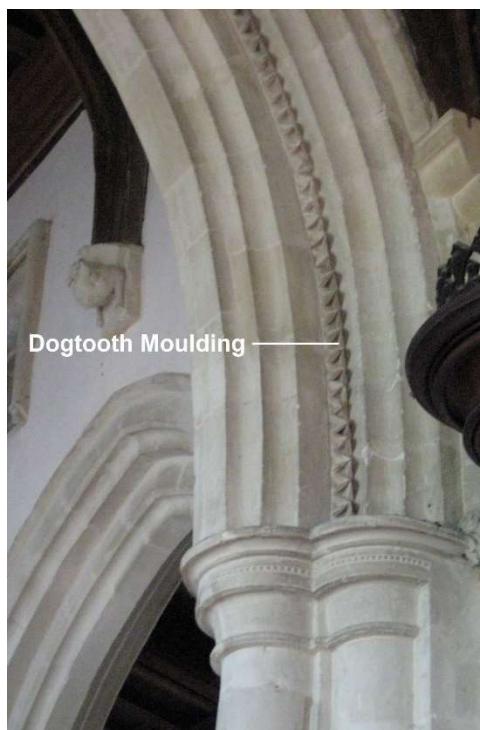
*Detail of the Chancel Arch*

Replacement of the early church with the current stone church began in about 1300, and the first element to be rebuilt was the Chancel, or the eastern section of the church. This rebuilding has been dated through the architectural detailing in the Chancel and, in particular, of the dogtooth moulding on the east side of the chancel arch. Dogtooth moulding was a decorative device widely used in the 13<sup>th</sup> Century, but as the Gothic period

progressed it largely disappeared from use, and was replaced with stylised leaves and similar decoration. At Whaddon the use of dogtooth moulding on a Gothic two centred (or pointed) arch has enabled a fairly precise dating for the rebuilding of this Chancel.

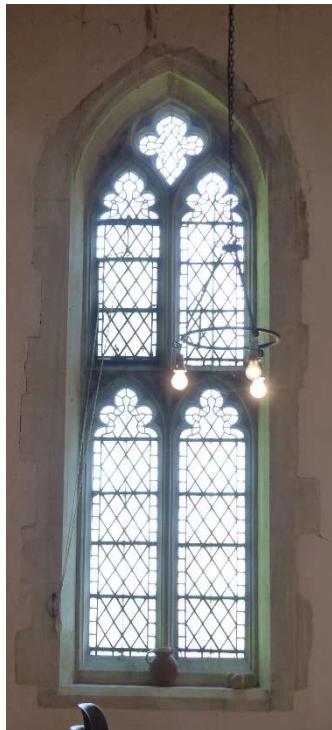
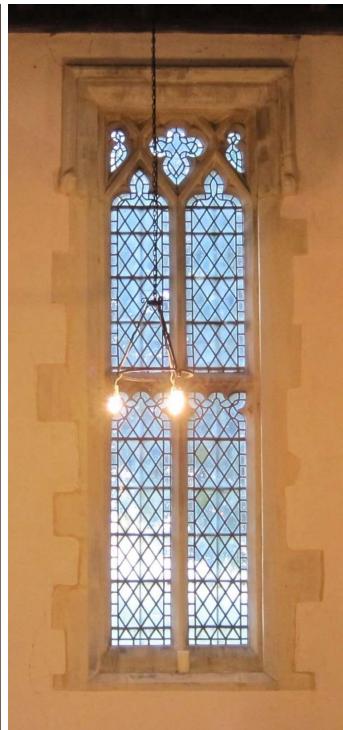
*Arch-headed window*

*Square-headed window*

Once the rebuilding programme resumed, I believe they started at the north-west corner of the church. I base that assumption on a comparison of the windows in the aisles. All the windows are square headed in what we now call '*Perpendicular Gothic*' style, but the one window at the west end of the north aisle has a two-centred arch to its head, suggesting it was built at a time of transition to the new *Perpendicular* architectural style (see photos).

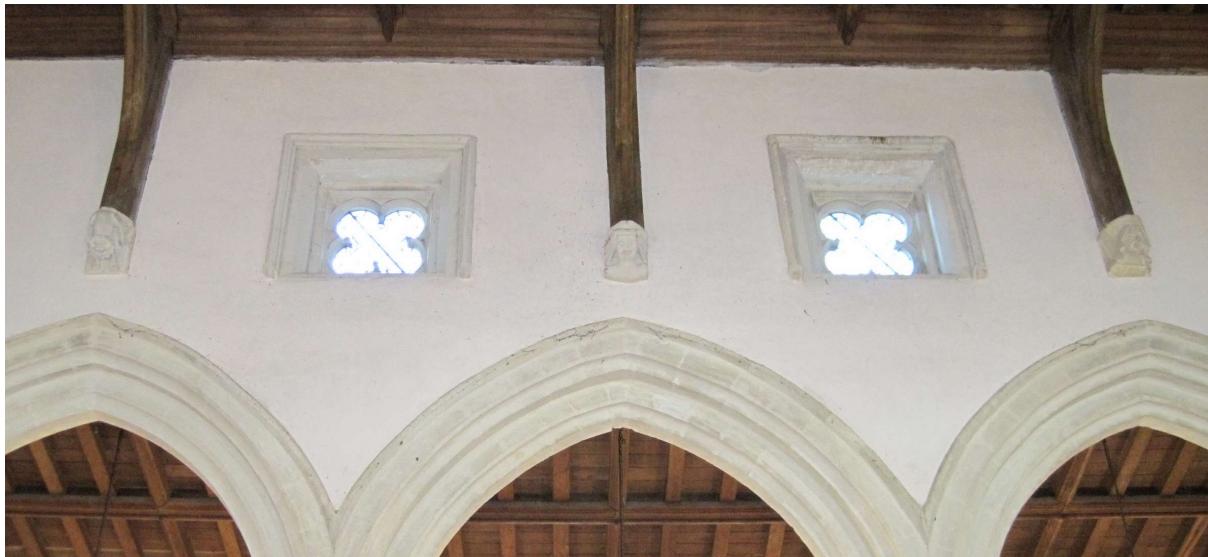
The 'Quatrefoil' windows to the clerestory above the arcades

Aside from this one different window, the design of the nave and aisles are very consistent and suggests they were completed in a relatively short timescale. The tall arcades between the nave and side aisles is very characteristic of the *Perpendicular* architecture of the period, along with the 'Quatrefoil' windows (square windows made up of four interlocking circles) in the clerestory above the arcades. When completed, the nave and aisles would have been empty of furniture; there were no pews or seats in early churches and everyone was

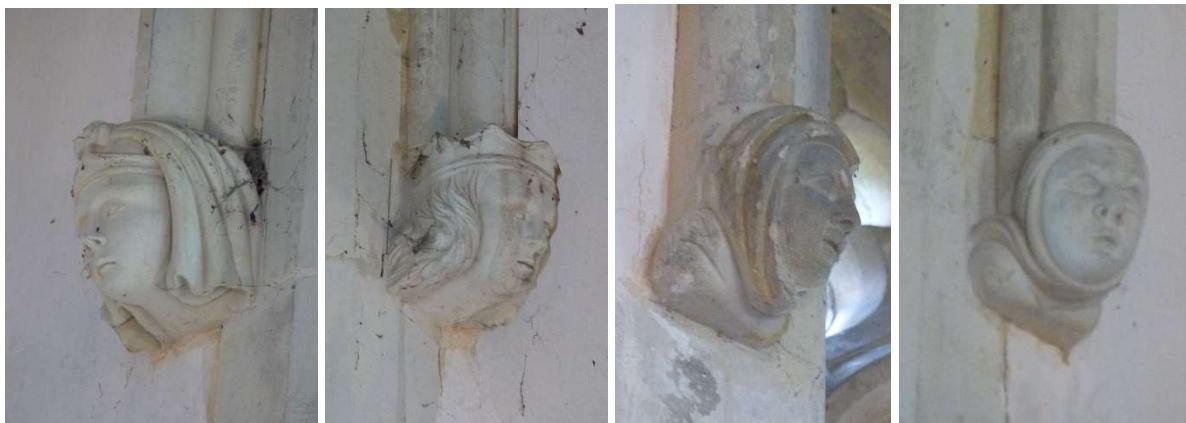
Carved heads from the label moulds to the aisle windows (south aisle left, north aisle right)

Over the square-headed windows on the side aisles are 'label moulds' which terminate with carved heads. The heads to the windows in the south aisle are quite different from those on the north aisle; the headwear suggest those in the south aisle are from the upper class, with one figure even having a coronet, whereas those on the north side are more humble. Do the south side figures represent family members of the de Scaler family, while those on the north side represent other, less affluent parishioners? We shall probably never know.

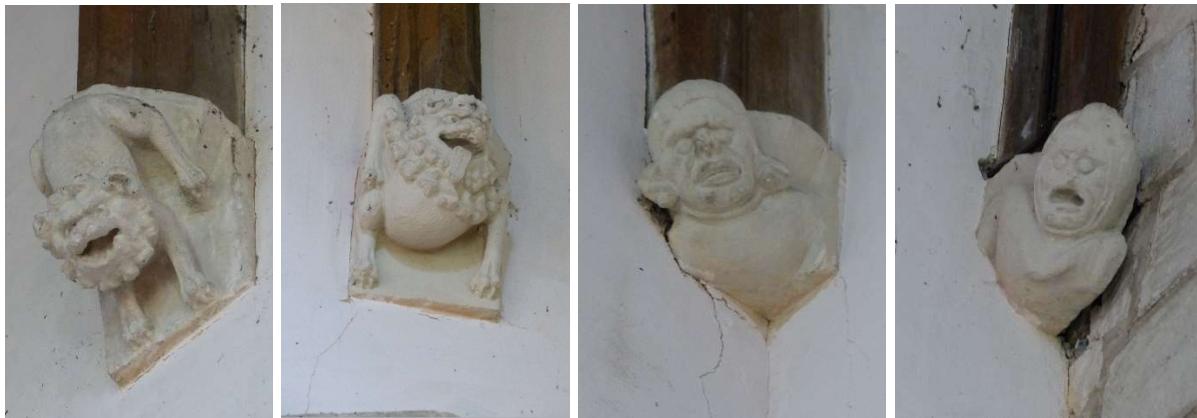
*Carved stone corbel brackets supporting the nave roof*

The nave roof also merits closer examination. It is supported on a series of carved stone corbels, many in the form of mythical beasts or grotesque heads. Within the timber roof structure are a series of carved wooded bosses, some in the form of a rose, while others appear to be of a lion's head, and one is of a *Green Man*, a mythical figure of medieval folklore interpreted as a symbol of rebirth, representing the cycle of new growth that occurs every spring. Superficially the Green Man may appear to be pagan, perhaps a fertility figure or a nature spirit, but he frequently appears in carved wood and stonework of churches, abbeys and cathedrals right across Europe. Perhaps this is evidence of the early Christian religion absorbing components of local pagan religions in much the same way as the feast of Christmas was aligned with the festival of mid-winter, where the lengthening of the days heralded the coming of the new spring and, for Christians, signalled the coming of Christ into the world.

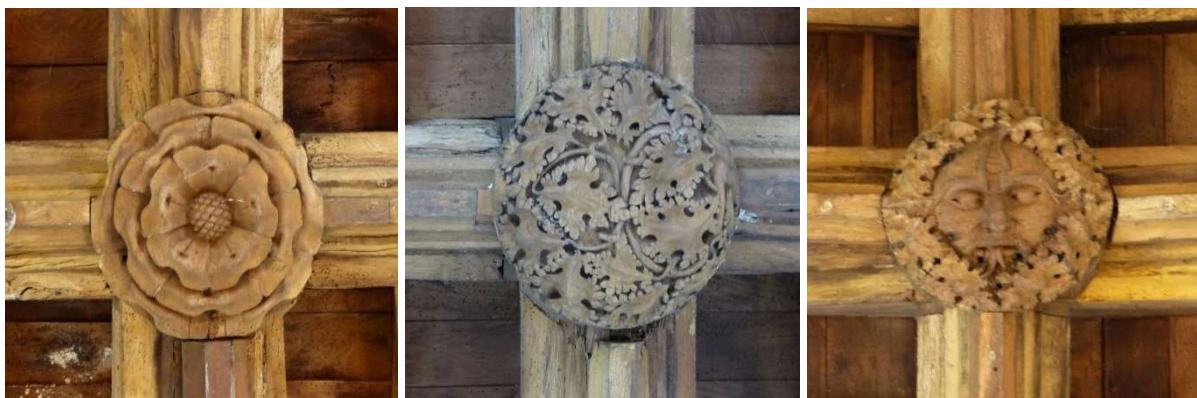
*Carved bosses to the nave roof, with Green Man on the right.*

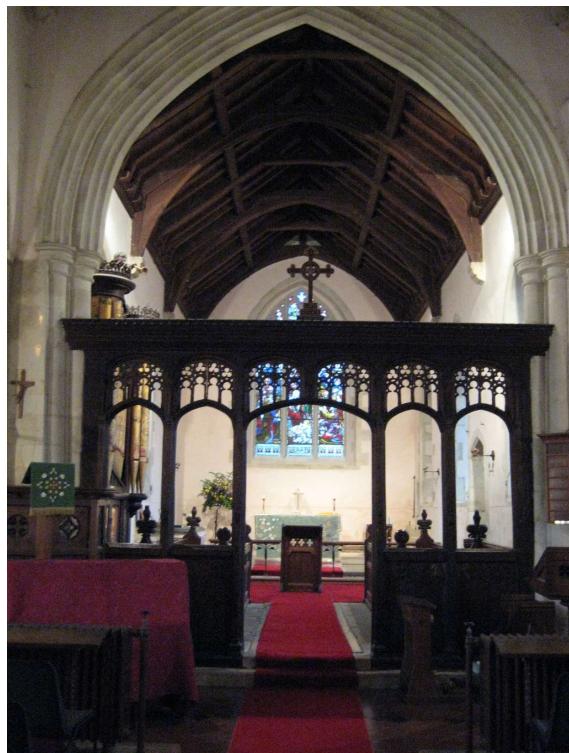
*The Rood Screen*

At about the same time that the tower was built a timber *Rood Screen* was installed within the chancel arch, separating the nave from the aisle. At that time the congregation would have been confined to the nave and aisles, and only the priest, and others officiating at the service, would have been allowed into the chancel, where the altar is located. The original *Rood Screen* would have been more substantial than what remains today, and included a gallery at high level, known as the *Rood Loft*, accessed via a narrow spiral staircase contained within the south-side of the chancel arch. A blocked doorway can still be seen that would have given access to this staircase, and a second blocked doorway is visible at high level, where the *Rood Loft* would once have linked to the top of the staircase. This gallery would have contained a large cross and statues depicting the Crucifixion ('rood' is the Anglo-Saxon word for cross), and the staircase would have been used each Lent, when these statues would be covered by purple cloth. A choir may also have sung from the gallery.

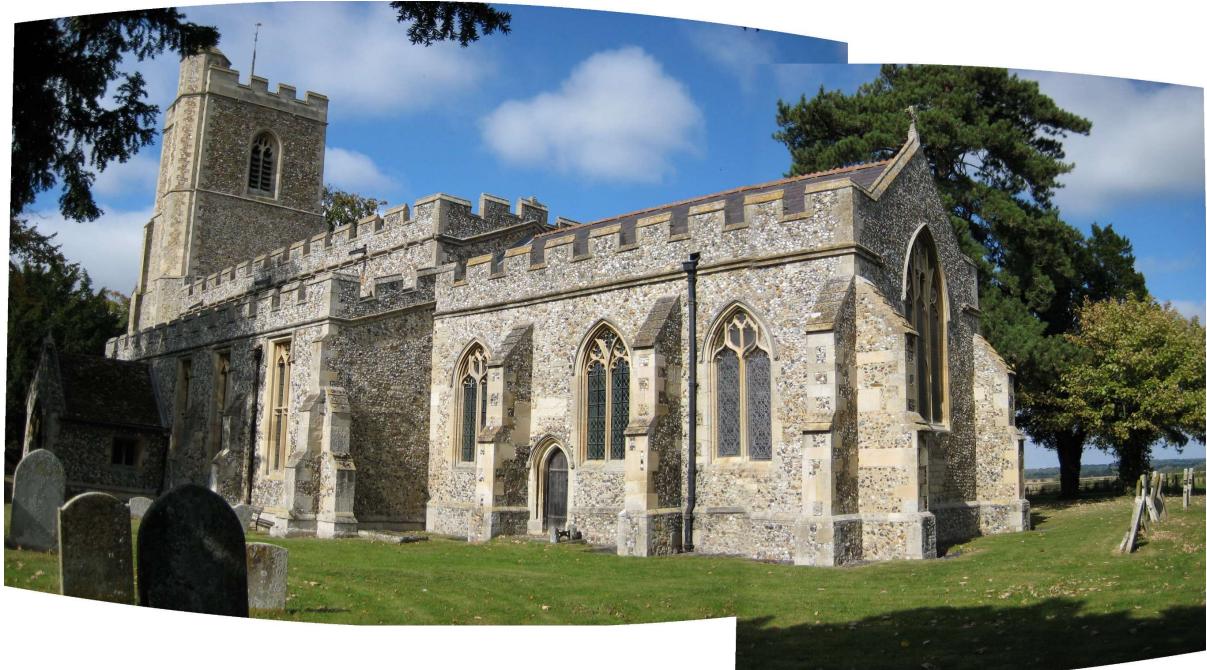
*Exterior view of the church showing the symbolic castellations to the walls and tower*

Externally St Mary's, along with a large number of churches, has castellations to the top of its walls and tower, somewhat similar to those on a castle, or the defensive wall around a city. But this church was never built to be defended, so why the castellations? Again the answer is that they are symbolic, and represent the city walls of the *New Jerusalem*, or God's Kingdom. A built manifestation of the well-known hymn that ends with the words:

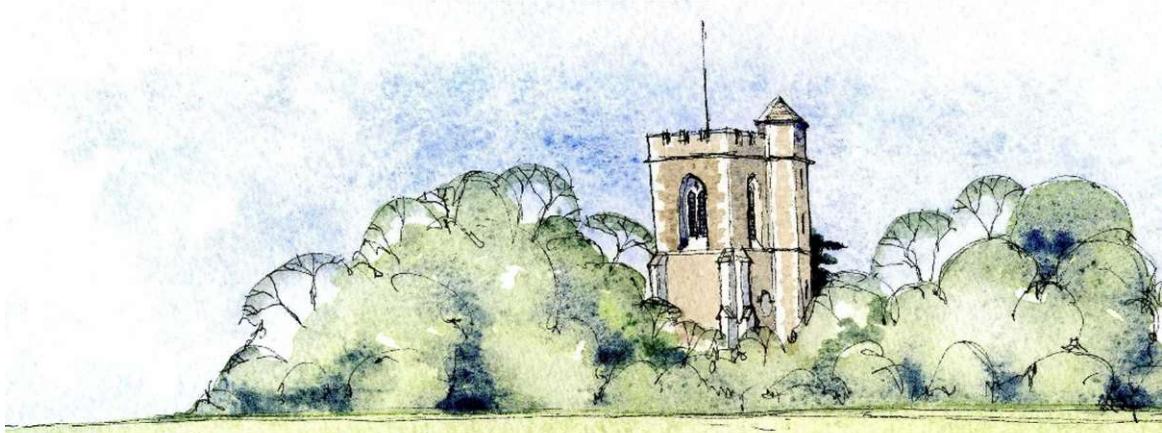
*The church tower, as the tallest structure in the vicinity, served as a symbolic link between heaven and earth.*

There is also a degree of symbolism in the height of the tower. At a practical level the tower contains the church bells, and the taller the tower in which the bells are hung, so the greater the distance over which they might be heard. And in days before widespread ownership of clocks or watches, it was important that the church bells could be heard in order to summon parishioners to services. But in medieval times a church tower was also the tallest structure in the vicinity and, therefore, was also able to serve as a symbolic link between heaven and earth. This symbolic 'reaching for the heavens' was, of course, even more pronounced on church towers that incorporated a spire. However by the early years of the 15<sup>th</sup> Century spires had fallen from fashion and there were very few built on Perpendicular west towers such as that at Whaddon.

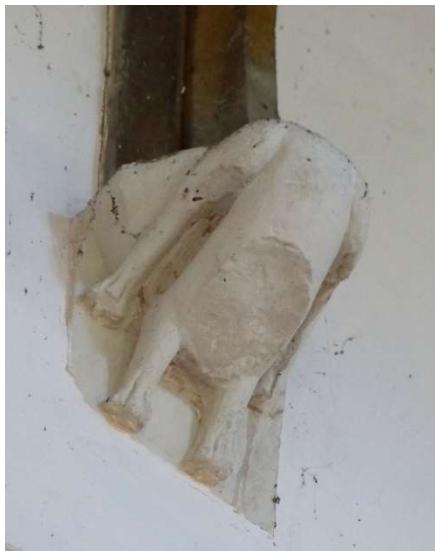
*Damaged carved stone corbel block supporting the nave roof*

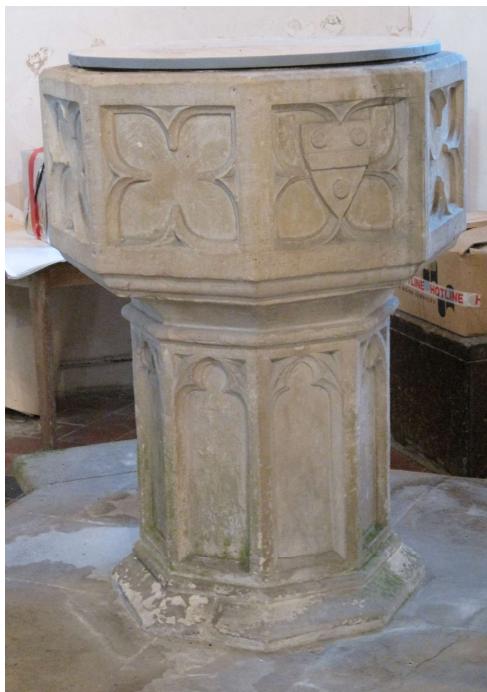
*Left; The font in the North Aisle*

The font is contemporary with the building of the tower, and dates from the 15<sup>th</sup> century. The font at Whaddon is relatively simple, with a 'chalice-like' shape comprising an octagonal bowl set on an octagonal shaft. The bowl is decorated with *Perpendicular Gothic* motifs incorporating pointed quatrefoil panels that also include the coat of arms of the de Scaler family in the panel facing east (strongly suggesting that the family paid for this font). Unlike some church decorations, fonts survived the Reformation, as Protestantism retained the rite of Baptism.

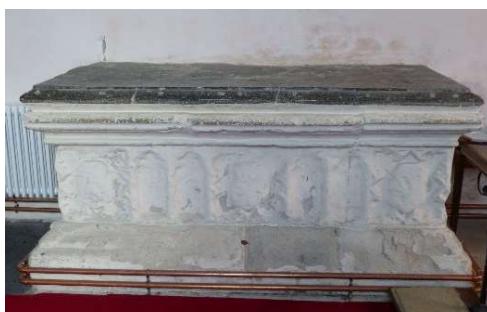
*The Chest Tomb in the Chancel*

There is a large chest tomb up against the north wall in the chancel. This is the tomb of John de Scaler, who died in 1467. It is made from the local clunch, with a top of black Purbeck marble, which would have had to be brought all the way from the Isle of Purbeck in Dorset. It probably would have been transported by sea to King's Lynn, then up the River Cam to Cambridge, before finally arriving by horse and cart. This chest tomb was relocated to its current location in 1869 to make room for the enlarged organ.

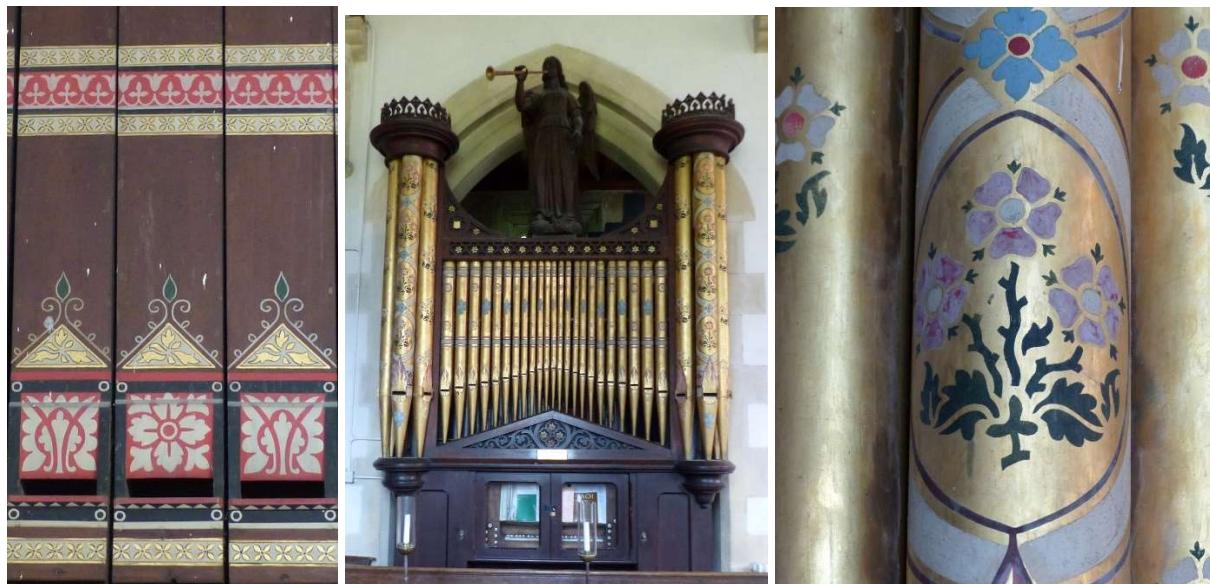
*The organ with its front pipes and stencilled decoration of 1869*

The organ, located on the north side of the Chancel, is also of some interest. The list description for the church records that it is said to be built by John Snetzler and was enlarged and remodelled in the 19<sup>th</sup> Century by J.W. Walker of London. More recent investigations undertaken in 2008 by Martin Goetz and Dominic Gwynn concluded that the organ is indeed based around a large 18th century chamber organ, but it is not a Snetzler. They write:

The organ was first placed in the church in 1857, expanded in 1863 and the decorative front pipes added in 1869.
